Three-Dimensional Breakwater Stability Tests at Vale de Cavaleiros, Cape Verde

by Ernest R. Smith, Jeffrey A. Melby

Final report

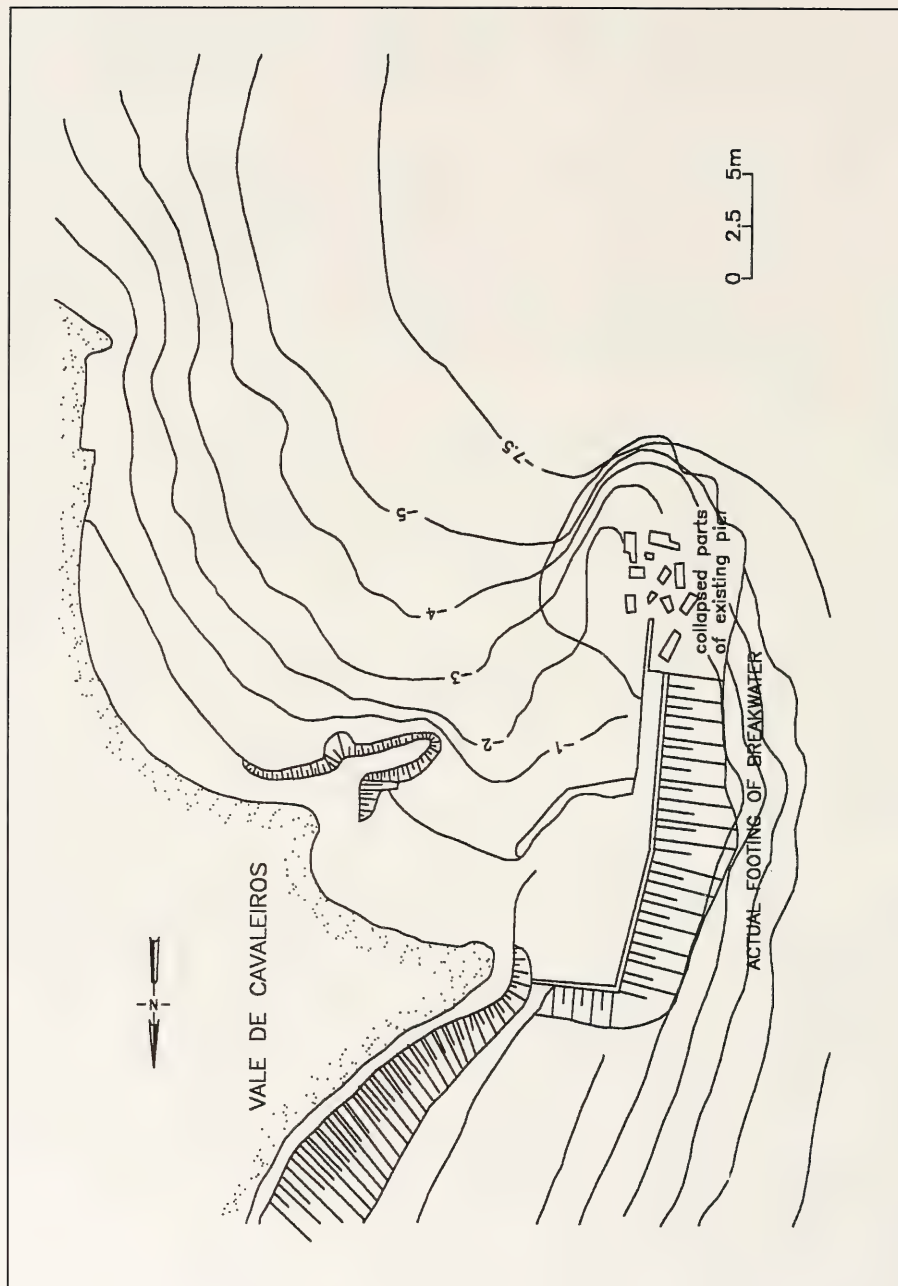
Figure 3. Existing site location map

The existing main breakwater is shown in Figures 3 and 4, with the layout view in Figure 4 dividing the breakwater into seven profiles. The porous breakwater consists of a traditional rubble mound fronting a recurved seawall. The crest elevation of the seawall is +8.15 m CD (CD refers to the lowest theoretical chart datum) while the crest elevation of the 6.25-tonne-tetrapod armor layer is approximately +7 m CD. The head of the breakwater was virtually destroyed by storms over 25 years and its remnants are completely submerged. The remaining tetrapod-armored trunk section extends south for approximately 180 m from Profile 1 (Figure 4). The existing tetrapod section extends down to approximately 0 m CD.

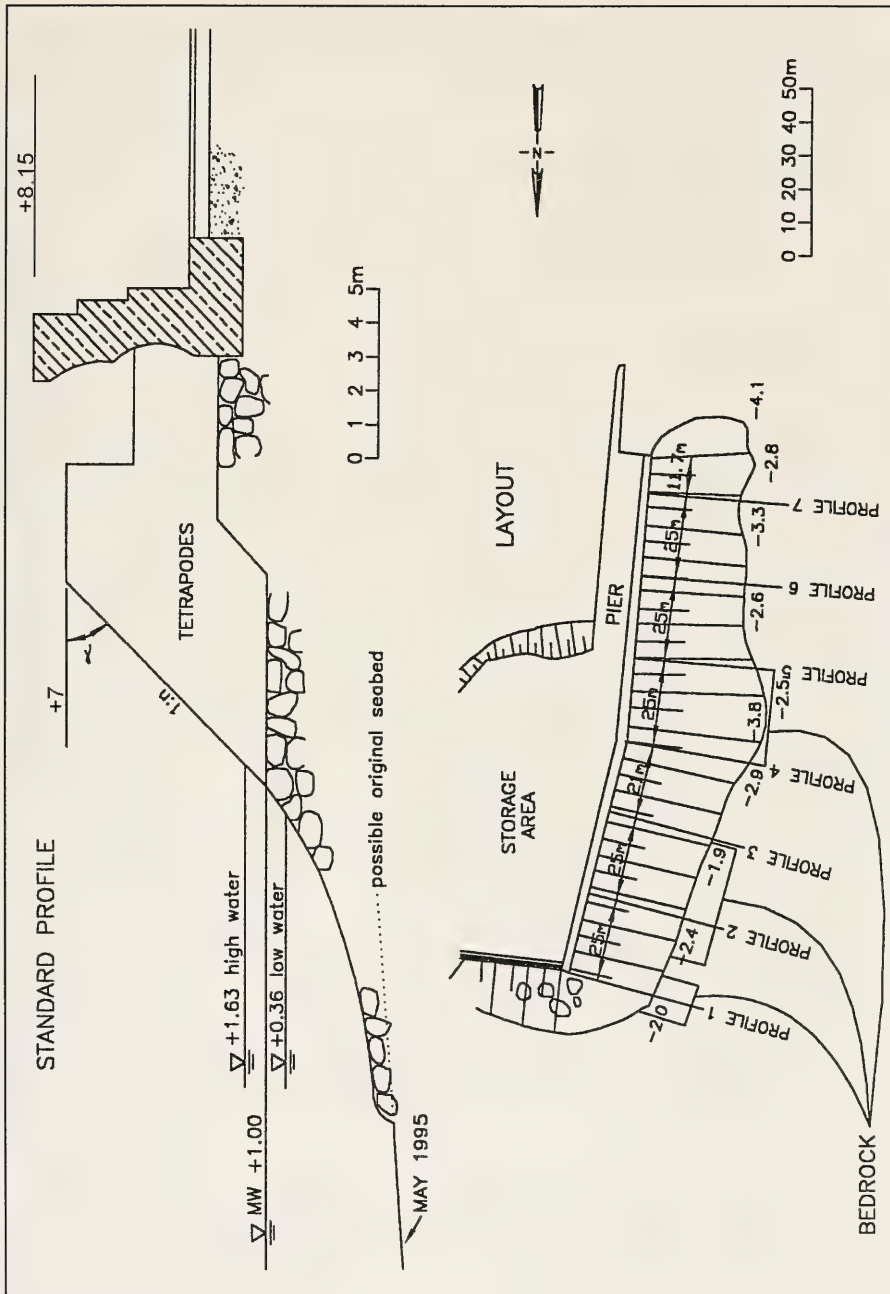
Figure 4. Existing structure

Much of the trunk section shows considerable damage to the existing tetrapod armoring. The main armor of tetrapods was under-designed for the 50-year return period, 7-m significant wave height at the head. Tetrapods along the trunk section north of Profile 4 have remained relatively stable.

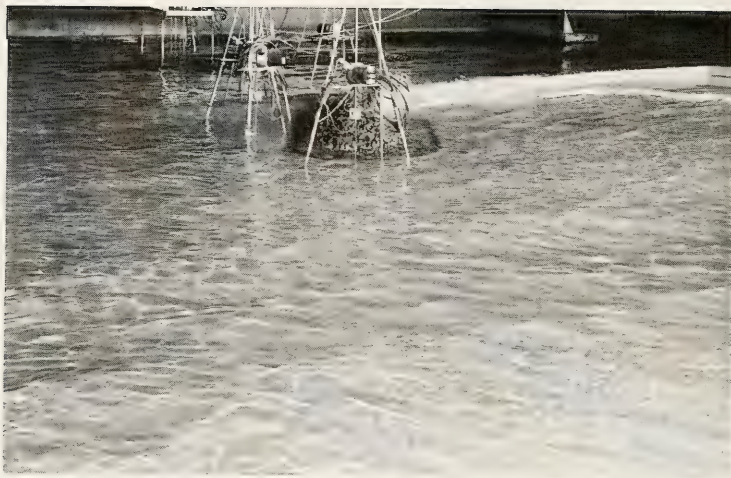
Figure 5. Three-dimensional stability model

Experiments were conducted in a 29.3-m-long, 29.6-m-wide, 1.5-m-deep wave basin. The model was constructed and molded of concrete to represent approximately 825 m of shoreline encompassing the harbor and breakwater location. Contours were molded to -20 m CD, and a 1V on 5H transition slope was molded from the -20-m contour to the model floor elevation of -21.3 m CD. Wave absorber was placed around the perimeter of the basin to minimize the effects of reflection. A photograph of the model is shown in Figure 5.

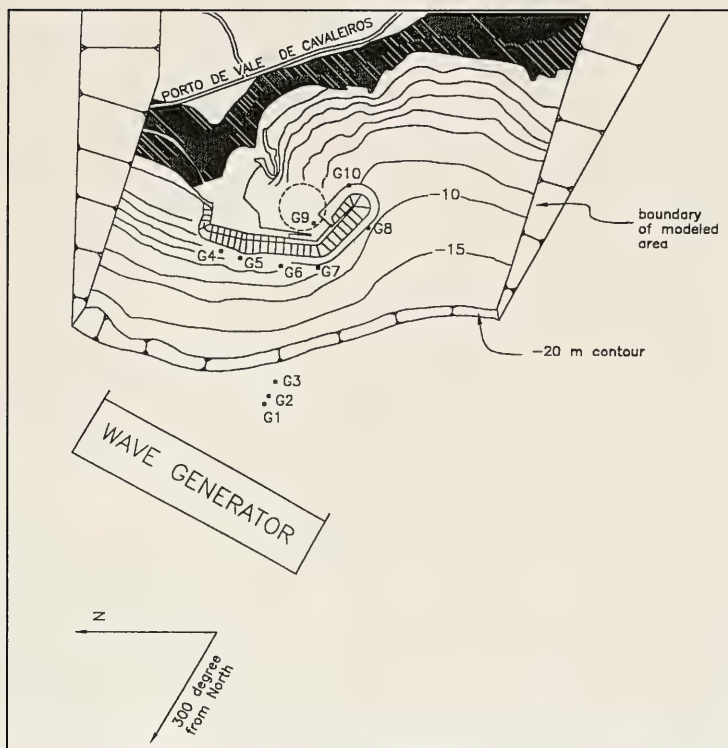
Figure 6. Three-dimensional model boundaries and wave gauge locations

calculation of incident and reflected wave heights by Goda and Suzuki (1976). The remaining gauges were placed at locations around the breakwater shown in Figure 6. Data obtained from the gauges were analyzed using the Time Series Analysis (TSA) computer program of Long and Ward (1987). Operations performed on wave data from individual gauges were mean down-crossing analysis to obtain significant wave height H_s , maximum and average wave heights, significant and average wave periods, and mean water levels at each gauge. Operations performed on the wave gauge array were unidirectional spectral density incident/reflection analysis to determine peak wave period T_p , and incident and reflected wave heights at the gauge array. Following calibration of the basin, Gauges 4 and 5 were removed and used in locations 9 and 10 during stability tests.

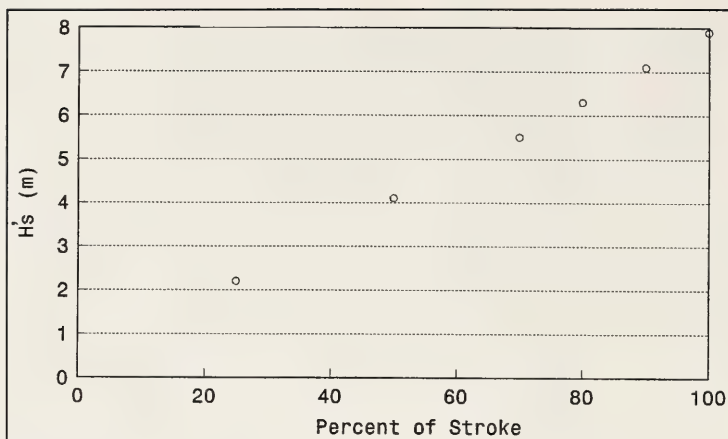
Figure 7. H_s' at -21.3 m CD versus generator stroke, 13-sec waves

Incident significant wave height H_s obtained from Gauges 1 through 3 during calibration is plotted versus percent of generator stroke in Figures 7 through 9.

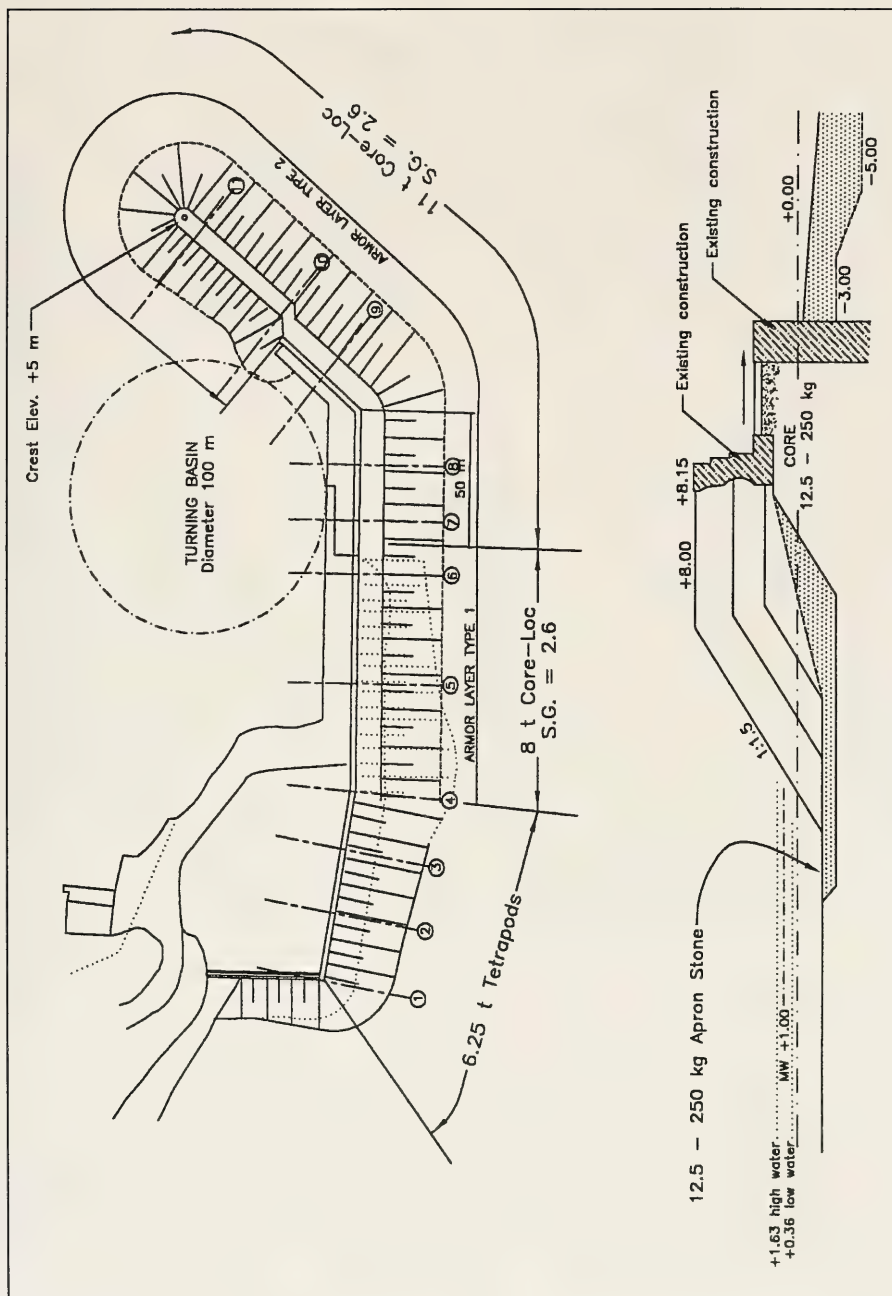
Plan 1, the initial plan (Figure 10, Photos A1 through A3), consisted of 6.25-tonne tetrapods from the shoreward end of the breakwater to Profile 4; 8-tonne Core-Locs from Profile 4 to a point between Profiles 6 and 7 (a total reach of approximately 92 m); and 11-tonne Core-Locs on the remainder of the seaward trunk, around the head and terminating at the quay wall on the leeward side of the structure. For this plan, packing densities of the 8- and 11-tonne Core-Loc reaches were 0.55 and 0.59, respectively. The crest elevation of the head section was +5 m CD. Plan 1 was subjected to “shakedown” waves (13 sec, 3 m) to settle and nestle the armor units. During the wave series, apron material was displaced between Profiles 4 and 9, and Core-Locs were displaced at the toe near Profile 4 (Photos A4 through A6). The structure was subjected to 3.7-m waves for 13- and 16-sec periods, which caused additional toe unit displacement at Profile 4 and at the elbow near Profile 8.

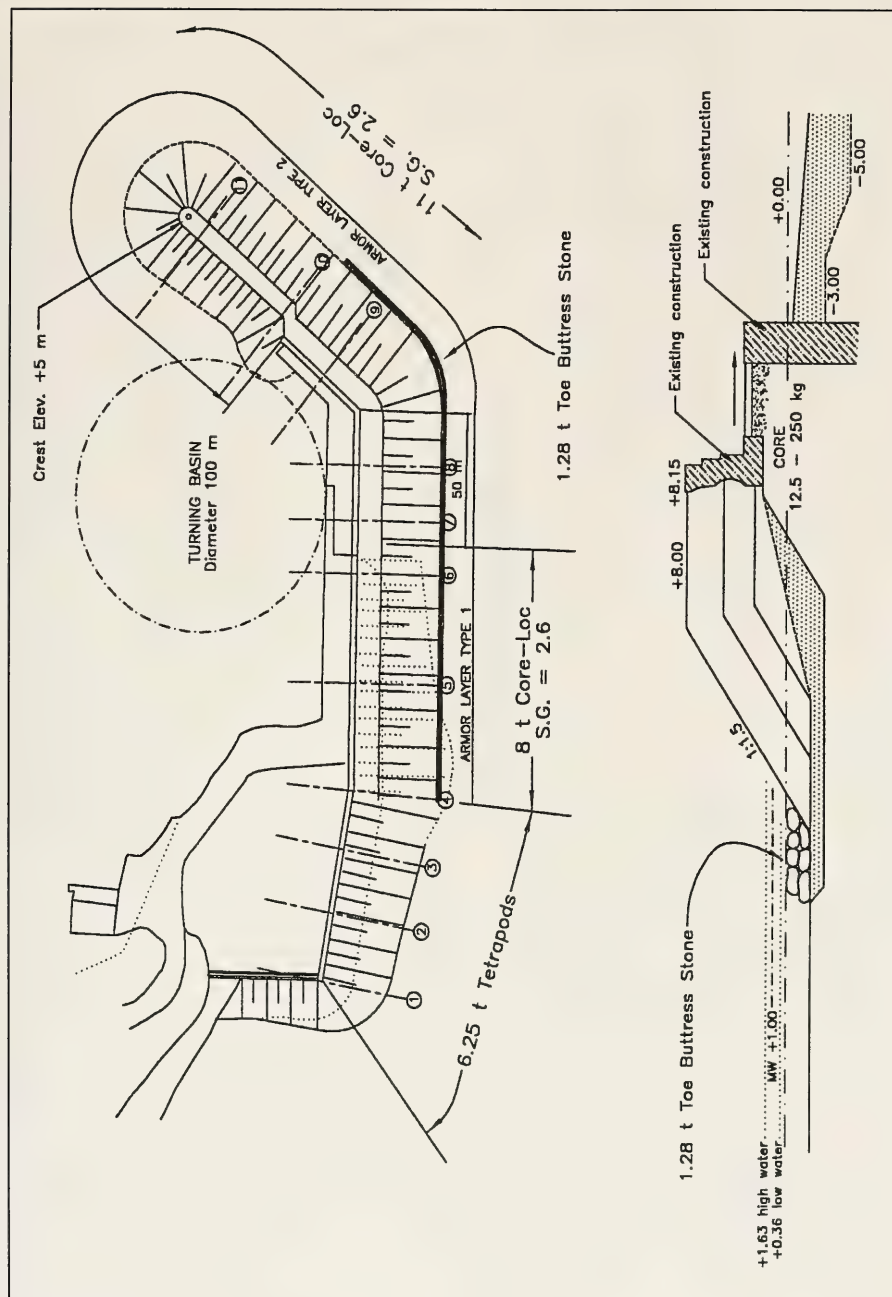
Figure 11. Elements of plan 1A

Plan 1A was the same as Plan 1 except a toe buttress was constructed of stone of identical weight as the underlayer stone (0.75 to 1.8 tonne) and placed between Profile 4 and the terminus of the quay wall near Profile 10 (Photos A7 through A9). The buttress was placed two stones high and three stones wide

(Figure 11). The 8-tonne Core-Loc armor layer was rebuilt resulting in a packing density of 0.60. The buttress material was displaced between Profiles 4 and 5 and between Profile 8 and the elbow of the structure during 13-sec, 3-m waves. Core-Locs in the vicinity of Profile 4 began to slide seaward, but the structure remained stable. However, the buttress was removed during 13-sec, 3.7-m waves between Profiles 4 and 6 and toe units in this region began to move. Eight-tonne units were displaced between Profiles 4 and 5 during 16-sec, 3.7-m waves and a hole developed at the crest near Profile 4 (Photo A10). The larger units, 11 tonnes, remained stable during Plan 1A tests (Photos A11 and A12). It was noted that the steep approach slope and the shallow depth in this region produced breaking waves that plunged along the toe region. The plunging breakers caused apron material to erode and forced the toe Core-Locs away from the structure.

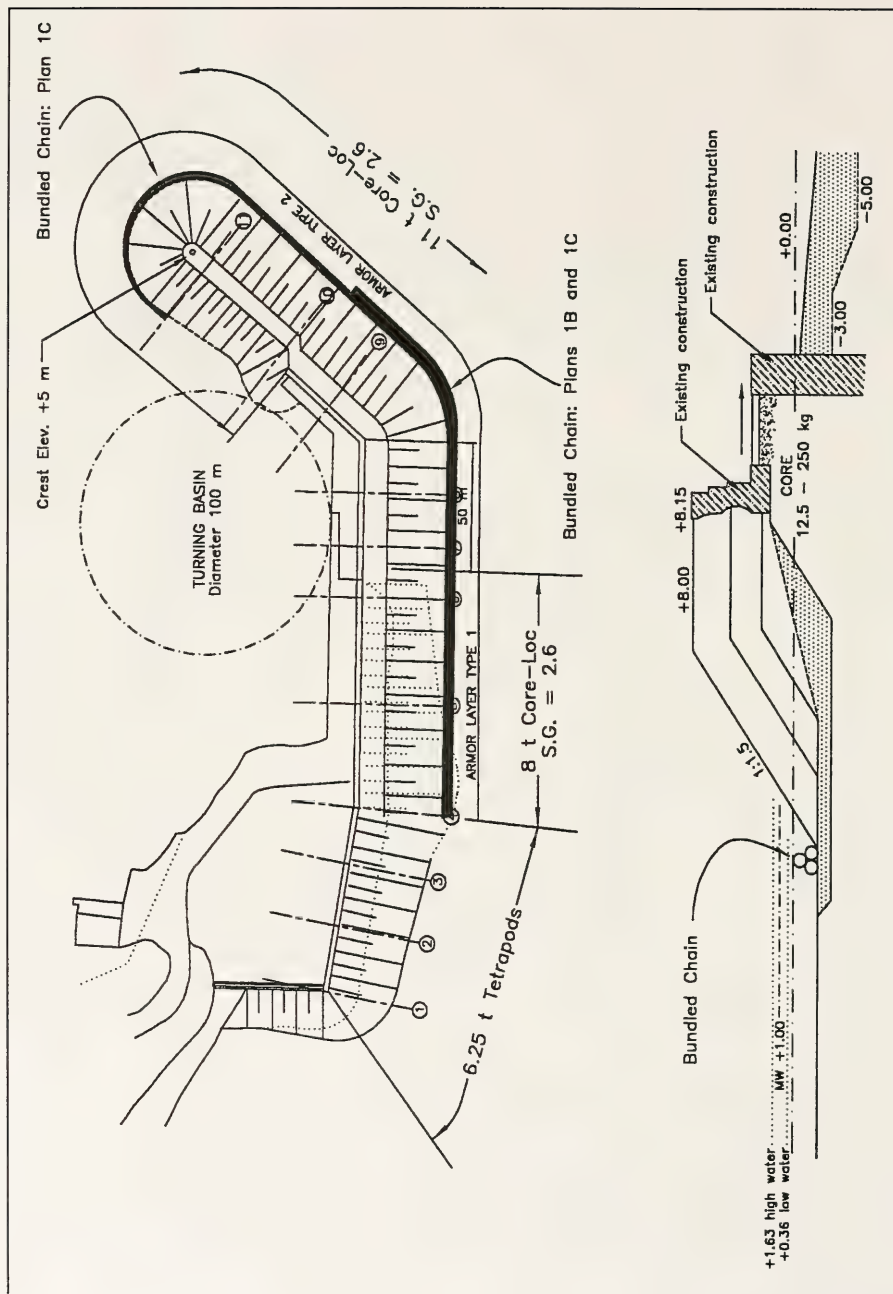
Figure 12. Elements of plans 1B and 1C

Plan 1B was identical to Plan 1 except three widths of bundled steel chain were placed along the toe from Profile 4 to the elbow (Figure 12). A single chain was placed at the toe at the elbow to the terminus of the quay wall. Additionally, a single chain was placed around the toe of the tetrapod section. The purpose of the chain was to stabilize the toe to observe the stability of upslope units. Rebuilding of the 8-tonne Core-Loc section resulted in $\phi = 0.60$. The addition of the chain stabilized the Core-Locs at the toe; however, wave energy also displaced the chain and it was necessary to reposition the chain between wave series. The armor layer loosened between Profiles 4 and 5, and apron material was displaced for wave conditions up to 17-sec, 5.2-m, but the section remained stable (Photo A13). During the 17-sec, 5.2-m condition, 11-tonne units at the toe near Profile 10, which was unprotected by the chain, were removed by waves, causing the upper units in this area to be displaced. A hole developed in the armor layer near the crown at Profile 10, which increased in size and migrated "north" along the structure (Photos A14 through A16). Additionally, green water overtopping was observed over the +5-m CD breakwater section for waves 3.7 m in height and greater. The severe breaking condition migrated to deeper water as peak period and/or wave height increased.

Plan 1C was the same as Plan 1B except three widths of steel chain were included along the toe from Profile 4 to the leeward side of Profile 11 for Plan 1C (Figure 12). In addition, the chain was anchored to the breakwater at approximately 8-m (prototype) intervals using pins inserted under the structure. The breakwater was rebuilt prior to experiments and the resulting packing densities for the 8- and 11-tonne Core-Locs were 0.62 and 0.59, respectively. The structure was stable for waves up to 6.7 m, but it was observed that the armor layer loosened in areas between chain anchors. During 16-sec, 6.7-m waves, one

11-tonne and three 8-tonne toe units were displaced. The toe failed near Profile 10 during 19-sec, 6.7-m waves at a location where the chain was forced seaward between anchors (Photos A17 through A19).

Plan 1C was rebuilt and repeated with additional pins used to anchor the chain to the structure. Packing densities remained the same as the original Plan 1C. The plan was subjected to the entire storm series and was moderately stable. Three 8-tonne units were displaced between Profiles 4 and 5, and two 11-tonne units were displaced between Profiles 9 and 10 (Photos A20 through A22). All displaced units originated at the toe.

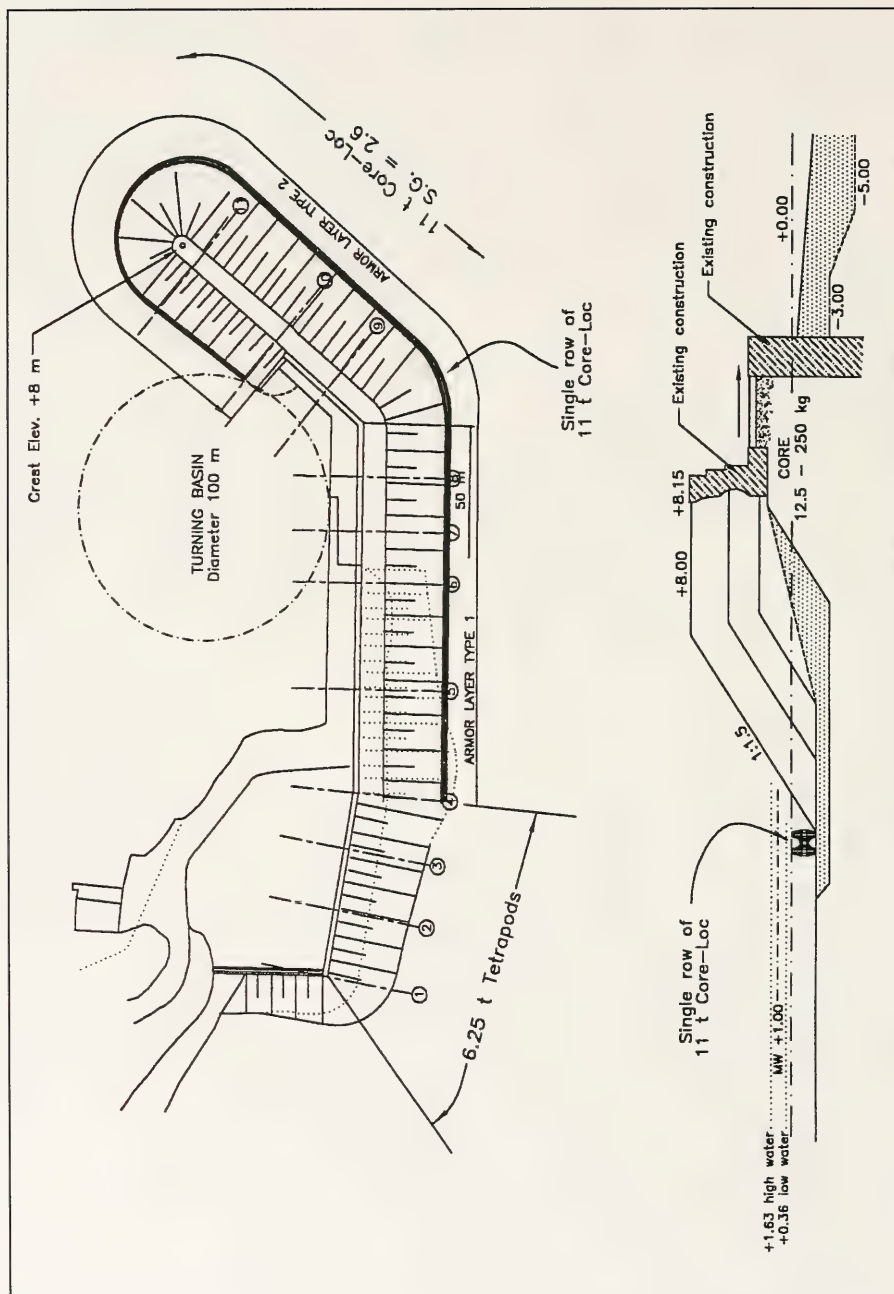
Figure 13. Elements of plan 2

Based on observations of the model and conversations with JV RRI-BCEOM personnel Messrs. A. Merrien and L. Fischer, Plan 2 consisted of raising the +5-m head portion of the breakwater to bring the entire structure to +8 m to reduce overtopping. The 8-tonne units were replaced with 11-tonne Core-Locs and the toe was reinforced with additional 11-tonne units placed in a single row (Figure 13). The packing density of the 11-tonne Core-Locs was 0.62. Toe protection units were placed 90 deg to the toe units of the structure in a manner in which adjacent units interlocked (Photos A23 through A25). The 11-tonne Core-Locs used for toe protection were displaced during 13- and 16-sec, 3.7-m waves, and the armor layer failed due to toe instability (Photos A26 and A27).

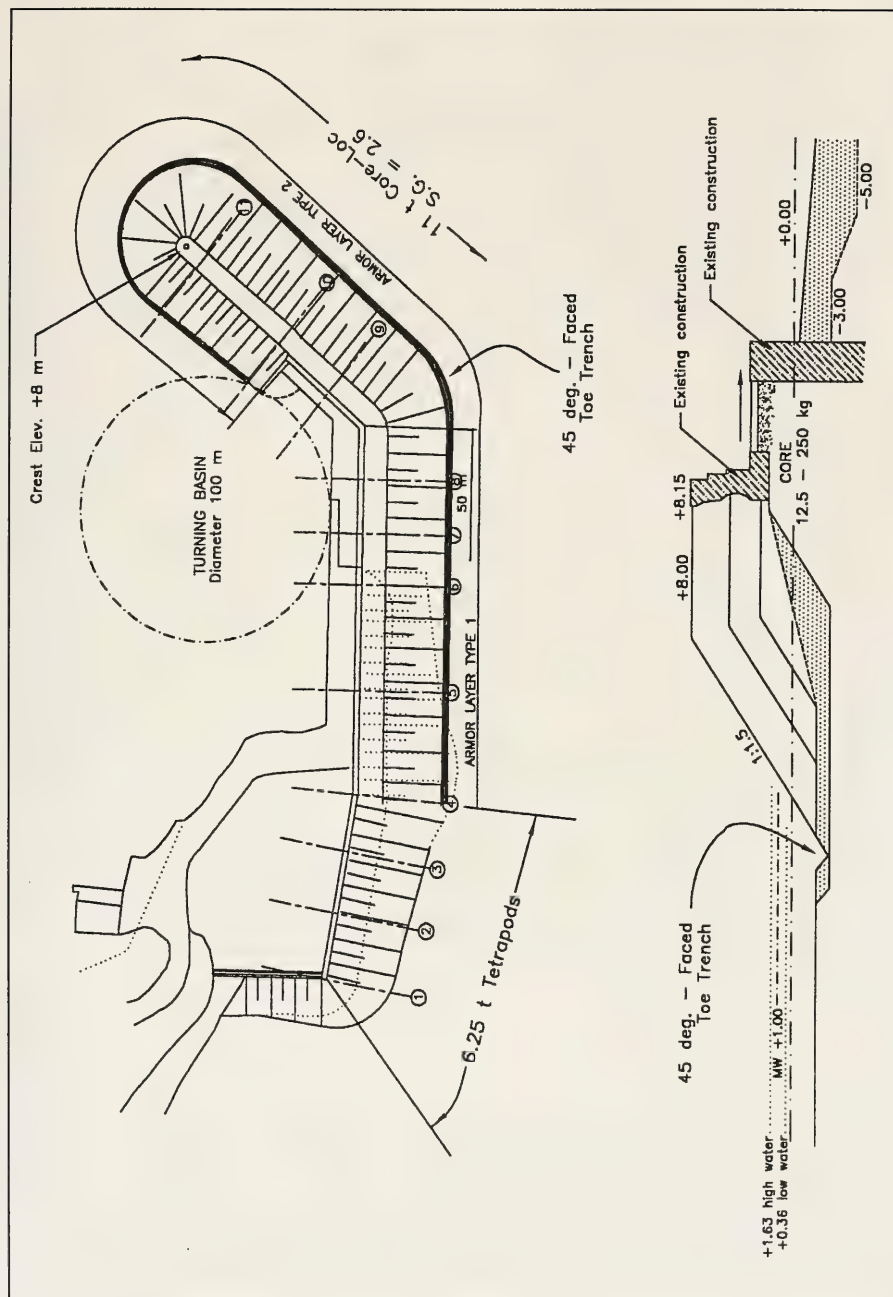
Figure 14. Elements of plan 2A

Plan 2A was the same as Plan 2 except the single row of 11-tonne Core-Locs was replaced with a wood board anchored to the floor around the entire Core-Loc armor layer to act as an immovable toe restraint. The board simulated a toe trench 1 m deep and included a 45-deg bevel adjacent to the toe unit (Figure 14). The plan consisted entirely of 11-tonne Core-Locs ($\phi = 0.61$) beginning at Profile 4 with a crest elevation of +8 m CD throughout the structure (Photos A28 through A30). One toe unit was displaced during 16-sec, 3.7-m waves near Profile 5, but the structure was stable for waves up to 16-sec, 5.2-m waves. During the 16-sec, 5.2-m condition, one toe unit was displaced near Profile 6, one toe unit was displaced from Profile 9, and three toe units were displaced near Profile 10. No further displacement of Core-Locs was observed for 19-sec, 5.2-m or 13-sec, 6.7-m waves; however, underlayer stone was observed to be displaced between Profiles 4 and 6 in areas of toe displacement. Additionally, the armor layer began to loosen in this area. During 16-sec, 6.7-m waves, 16 additional toe units were displaced, producing noticeable damage to the structure. Most of the armor was displaced off the structure at the elbow between Profiles 8 and 9 during 19-sec, 6.7-m waves (Photos A31 through A33).

- b. Plans 2A and 2B included a board anchored to the model floor at the base of the breakwater to stabilize the toe. Analogous results would be expected if a toe trench was used to fix the toe. The board used in Plan 2A was 1 m deep and included a 45-deg angle adjacent to the toe units. The sloped trench was stable for waves up to 16 sec, 5.2 m but significant damage occurred between Profiles 8 and 9 for 16-sec, 6.7-m waves. The trench simulated in Plan 2B was 1.5 m high and had a vertical face. Plan 2B was stable for original and repeat tests; one unit was displaced during the repeat tests, but the structure remained stable.

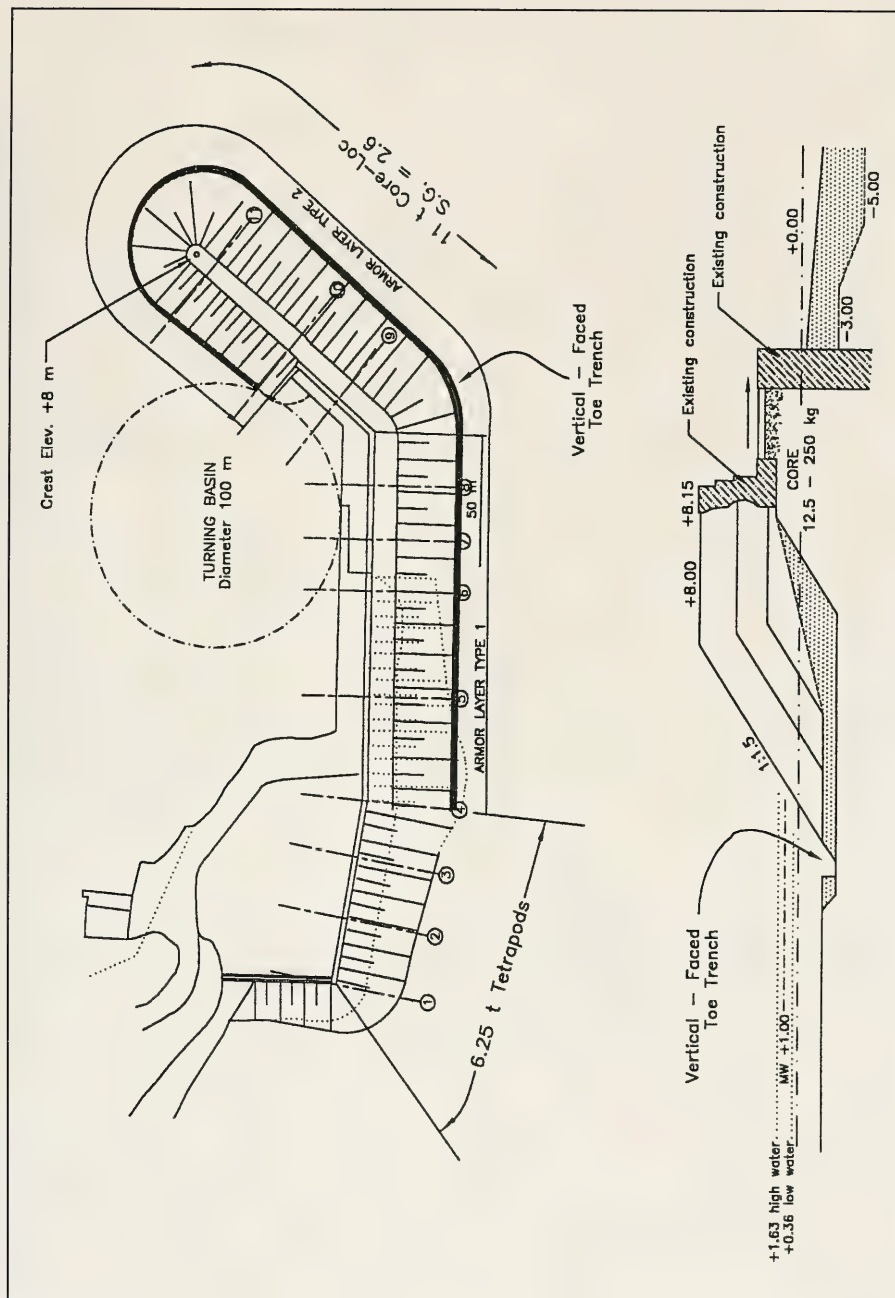
Figure 15. Elements of plan 2B

Plan 2B was identical to plan 2A except the toe reinforcement was constructed using a board anchored to the floor to represent a toe trench 1.5 m high with vertical sides (Figure 15). The breakwater armor was rebuilt and the packing density for the 11-tonne Core-Locs was 0.63. To expedite the study, all 3.7-m waves and the 13-sec, 5.2-m condition were omitted for this test series. From previous experiments with plans which included a restrained toe, the omitted wave conditions caused no or only minor damage to the breakwater. No units were displaced during this series (Photos A34 through A36). Plan 2B was rebuilt with the same packing density and the experiment was repeated. One Core-Loc was displaced off the head midway through 19-sec, 6.7-m waves, but the structure remained stable throughout the rest of the wave condition.

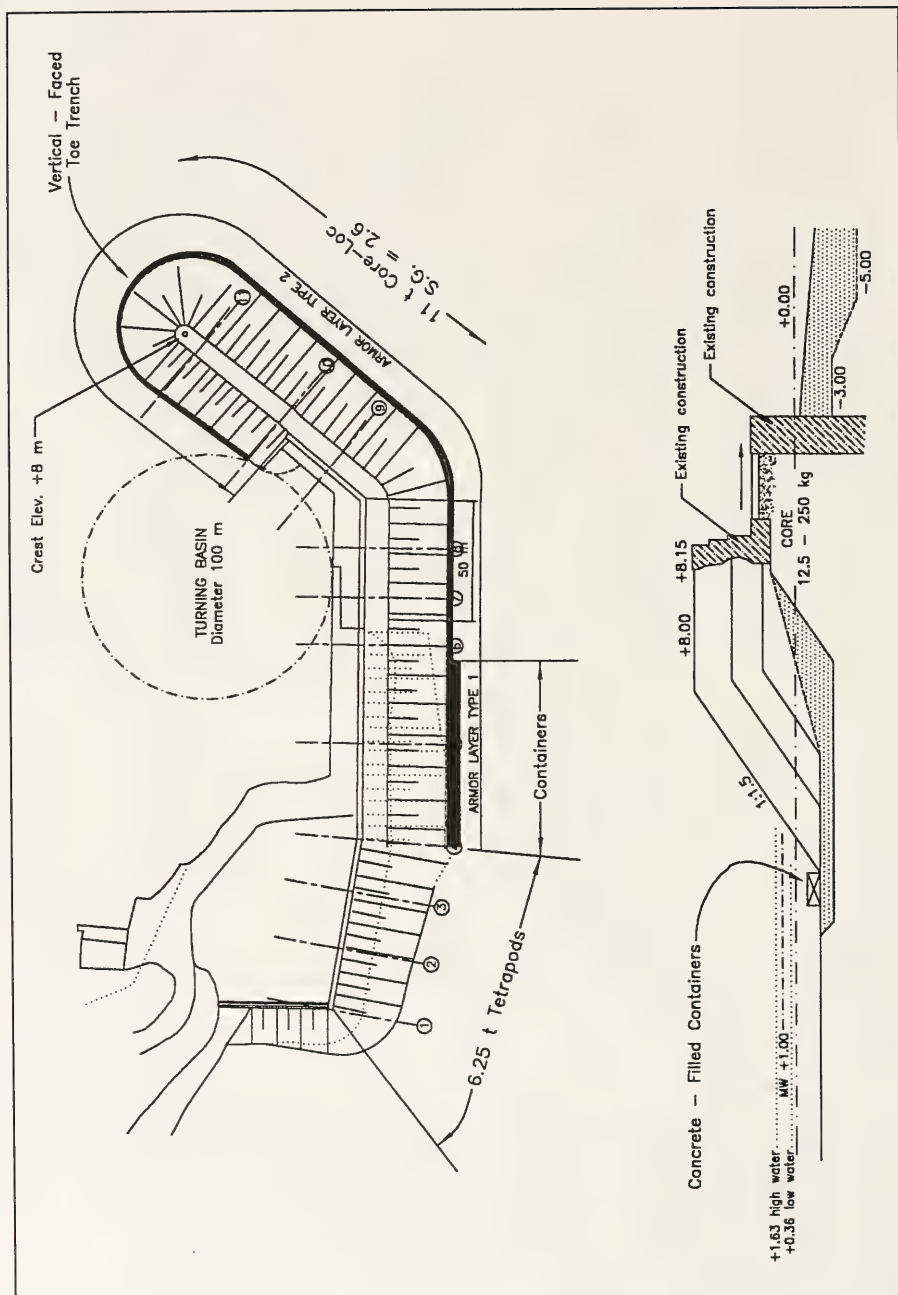
Figure 16. Elements of plans 2C and 2D

The breakwater was rebuilt entirely of 11-tonne Core-Locs ($\phi=0.63$), but the board used to simulate a toe trench was removed between Profile 4 to a location 70 m from the elbow (Figure 16, Photos A37 through A39). Model concrete blocks were placed in this area to simulate 6.1-m-long, 2.5-m-wide, 1.2-m-high cargo containers filled with concrete. The containers had an approximate prototype weight of 42.4 tonnes using a concrete specific gravity of 2.3 in the prototype. The containers were placed 1 m apart along the toe and 11-tonne Core-Locs were placed against the containers.

Plan 2D was identical to Plan 2C except the cargo containers were placed end to end along the Core-Loc toe (Figure 16, Photos A43 and A44). The armor layer was rebuilt with a packing density of 0.62. Results were similar to experiments with Plan 2C; the containers began to displace during 13-sec, 3.0-m waves and movement continued with higher waves. Eventually, all containers were displaced from their original position and moved southward along the breakwater. Without toe protection, Core-Loc toe units were displaced and upslope

units settled causing exposure of underlayer stone between Profiles 4 and 5 (Photos A45 and A46).

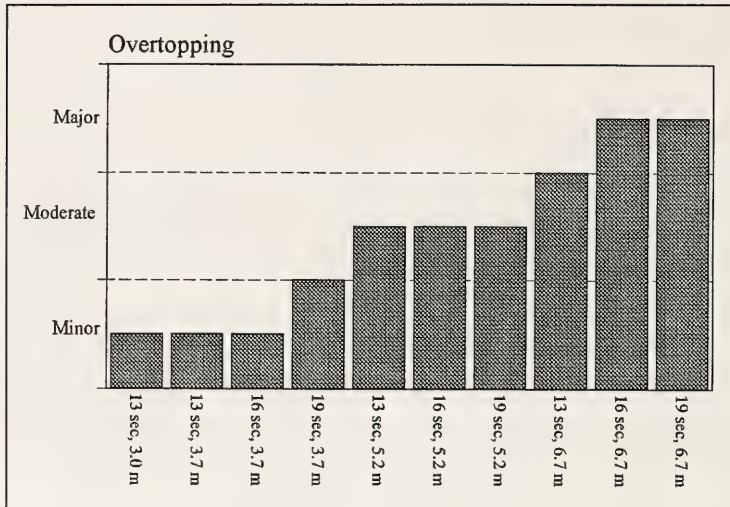
Figure 17. Wave overtopping at trunk, all plans

Overtopping was classified as minor, moderate, or major. Minor overtopping was defined for the present study as occasional or no overtopping. Moderate overtopping was defined as regular overtopping with occasional green water. Conditions that produced frequent overtopping and green water were classified as major.

The classification of overtopping (minor, moderate, or major) is plotted versus wave condition in Figures 17 through 19. The wave conditions in the figures are labeled from left to right by the sequence in which they were generated during the experiment, i.e., 13-sec, 3.0-m waves were generated first and 19-sec, 6.7-m waves were generated last. Figure 17 shows the amount of overtopping that occurred at the trunk for all plans. Major overtopping occurred at the trunk for 16-sec, 6.7-m waves, but was minor or moderate for all other conditions. Figures 18 and 19 show overtopping classifications for Plan 1 and Plan 2 series experiments at the head, respectively. The figures illustrate the reduction of overtopping by raising the crest elevation to +8 m CD (Plan 2 series) from +5 m CD (Plan 1 series).

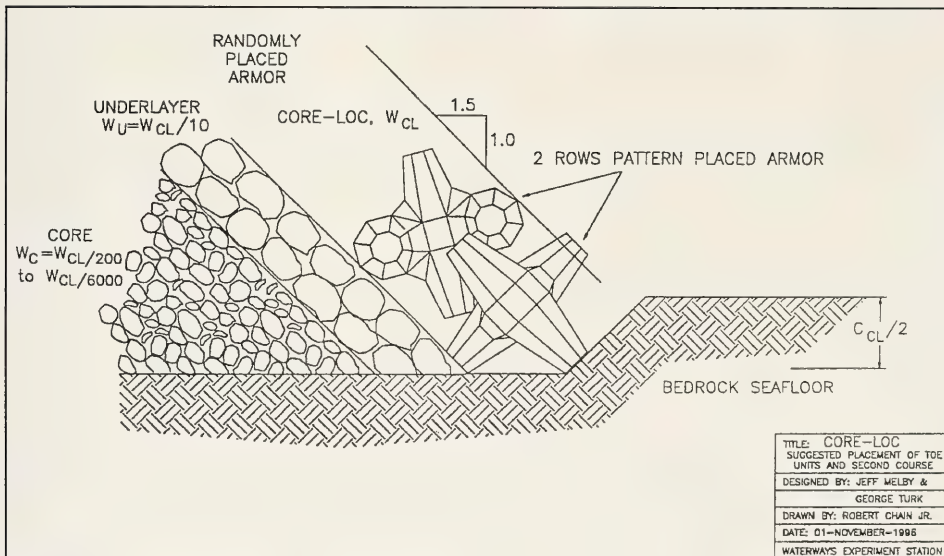
Figure 20. Example of toe trench constructed on rocky bottom

For the conditions tested in the model, the breakwater was not damaged if a stable toe trench, 1.5 m deep and near vertical, was installed. The model tests were conducted on a fixed bottom, which in nature would be analogous to a smooth rocky bottom in the prototype. An example of a prototype toe trench constructed in a rocky bottom is shown in Figure 20. The seaward face of the trench should be as near vertical as possible.

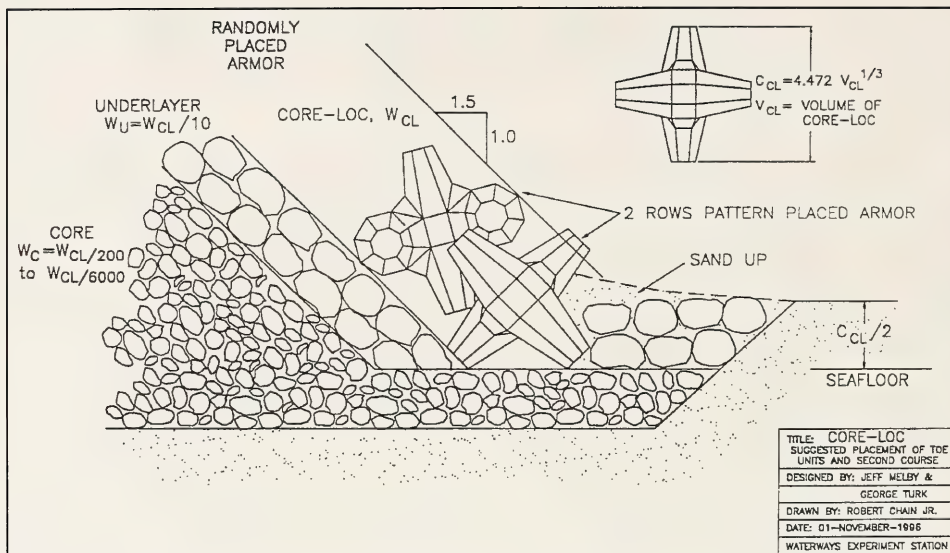
Figure 21. Example of toe trench constructed on sandy bottom

No model tests were conducted on stability with a movable bed; therefore, it was not possible to quantify the effects of a sandy bottom on the stability of the toe trench because the model floor was fixed. For structures placed in shallow water the *Shore Protection Manual* (1984) recommends a toe protection scheme similar to Figure 21, in which a wide trench is constructed and replaced with armor. The *Shore Protection Manual* suggests constructing the trench horizontally 2 times the water depth or 2 to 3 times the design wave height for the most severe scour.

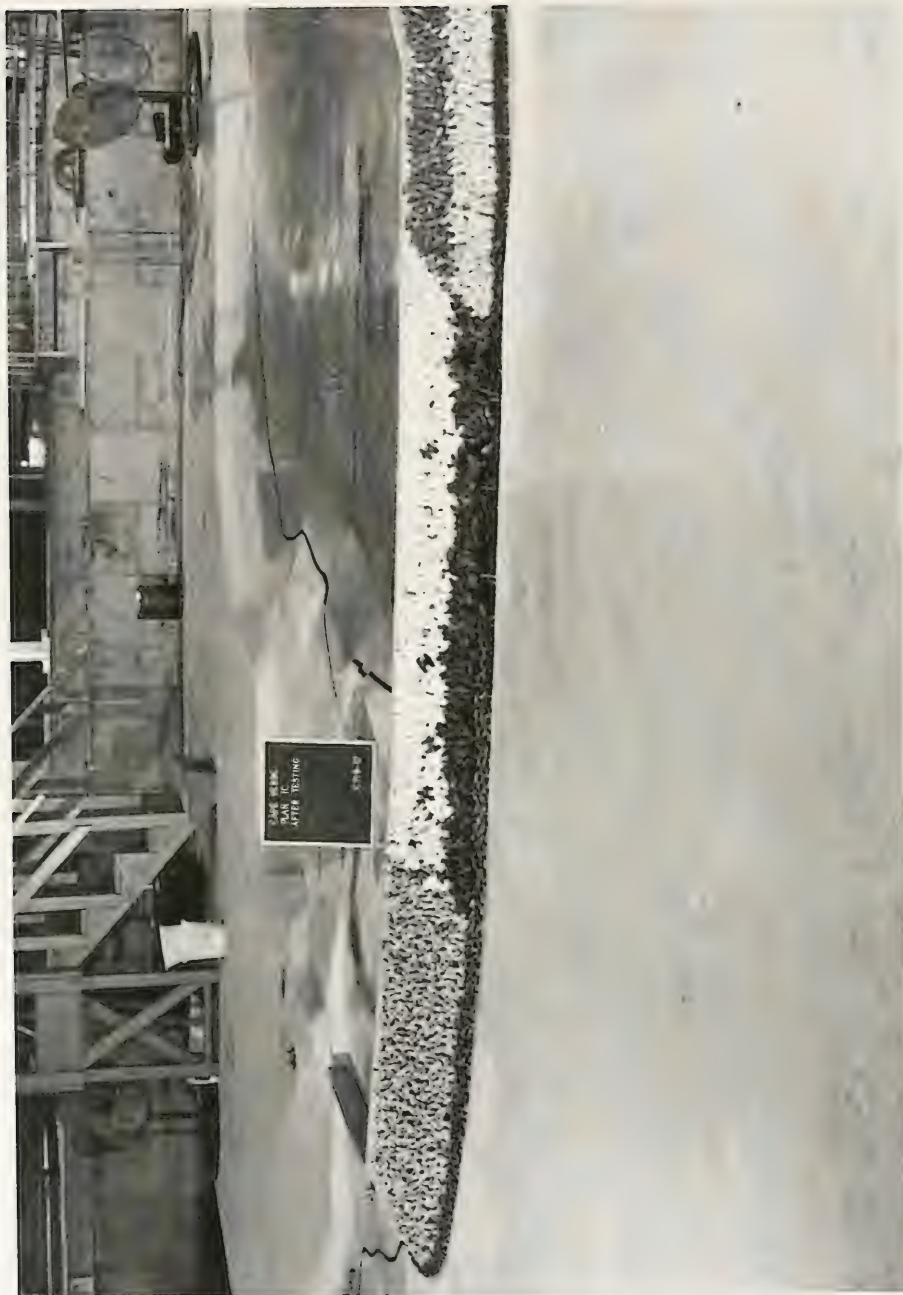
Photo A17. Sea-side view of plan 1C after testing with 19-sec, 6.7-m waves

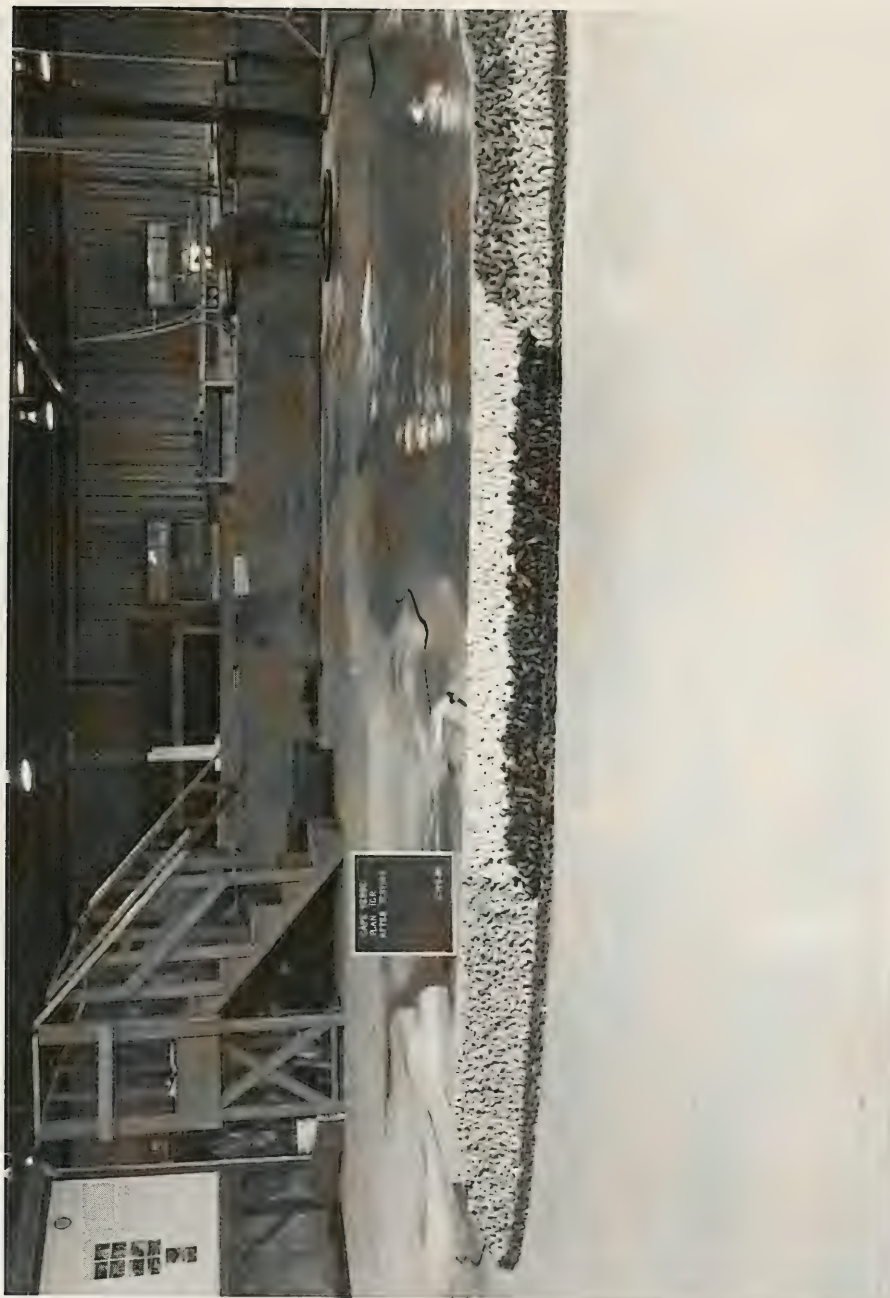
Photo A20. Sea-side view of plan 1C after repeat testing with total storm sequence

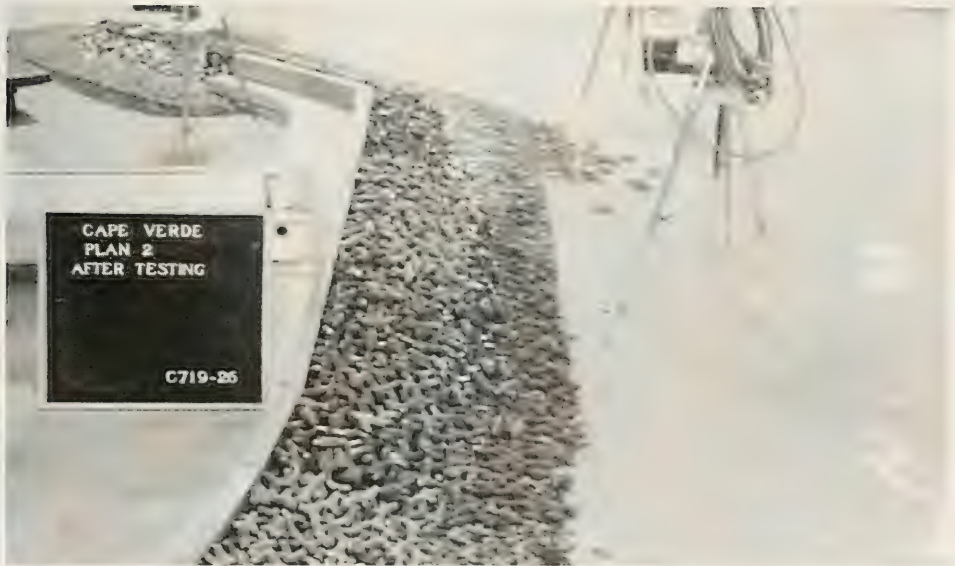
Photo A26. View from north of plan 2 breakwater trunk after testing with 13- and 16-sec, 3.7-m waves

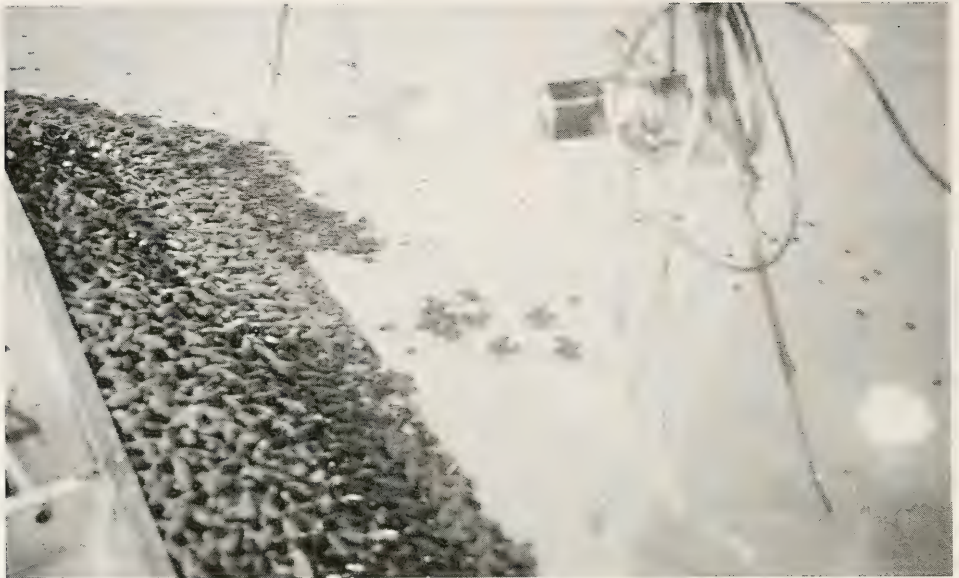
Photo A27. View of plan 2 breakwater trunk, profiles 6 to 8, after testing with 15-sec and 16-sec waves

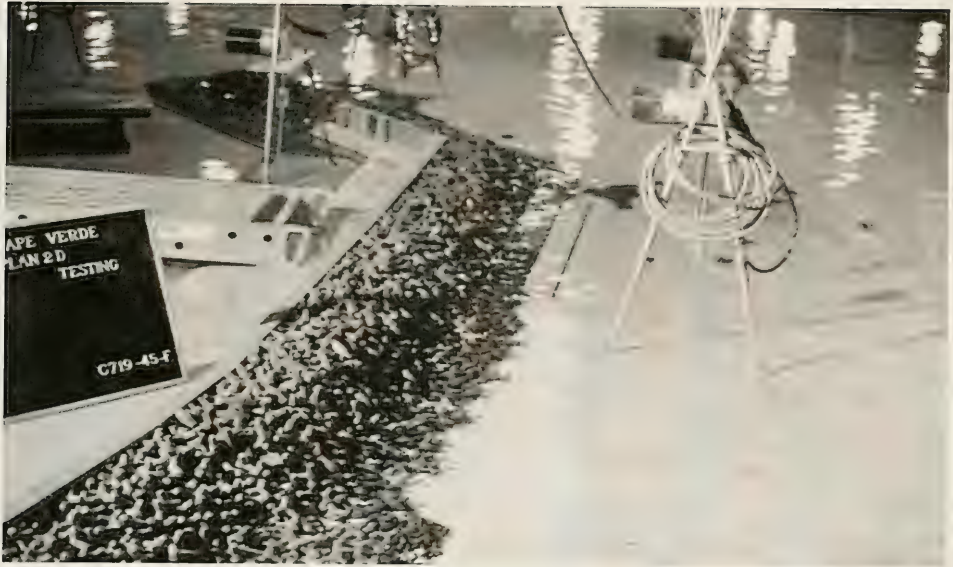
Photo A45. View from north of plan 2D breakwater trunk after testing with total sequence

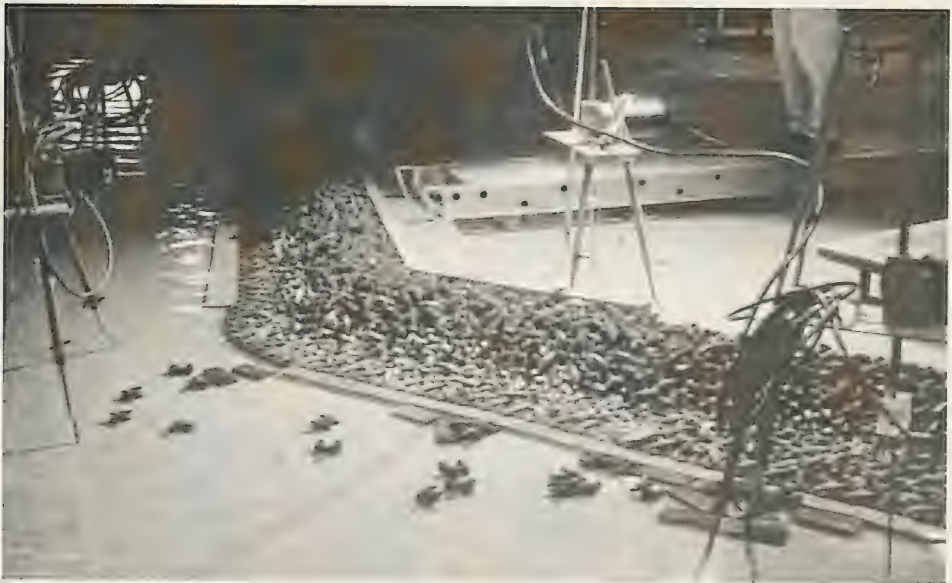
Photo A46. Sea-side view of plan 2D breakwater head after testing with total storm sequence
